Re: Curtain wall window investigation report and recommendations

Ypsilanti District Library- Water Infiltration Investigation

Terracon Consultants, Inc. (Terracon) has completed the building enclosure consulting services proposed in Terracon's Proposal dated June 28, 2019 and authorized on August 9, 2019. This report summarizes Terracon's site activities, documents the results of our observations, and provides general recommendations for repair.

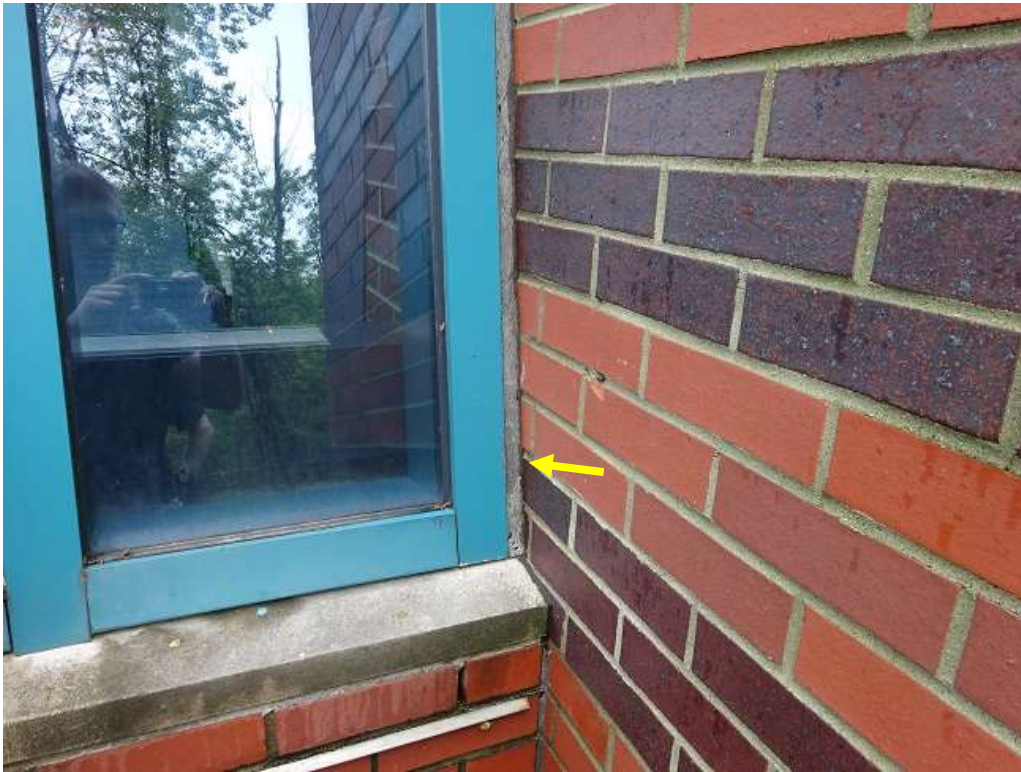
Photo 1

- The surface of the perimeter sealant joints are deteriorated with surface cracking and pitting noted. No section of disbonded sealant was identified from the ground **[Photo 1]**.

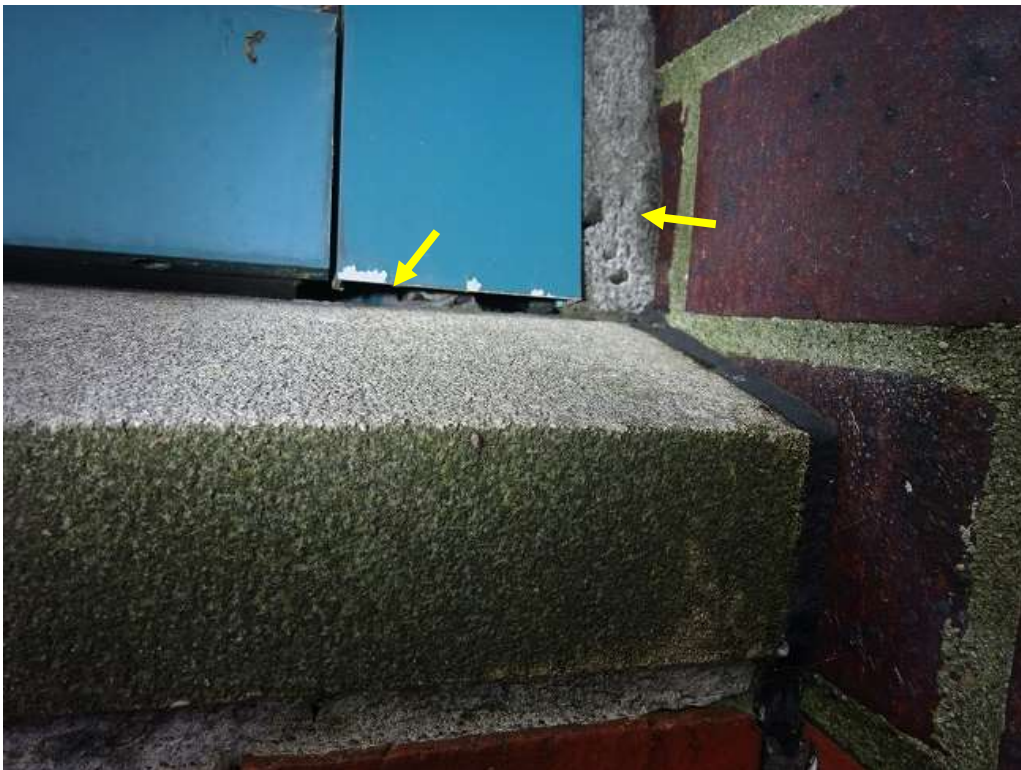
Photo 2

- The plane of the perimeter seal is not consistent between the jambs and sill condition, the perimeter seal is not visible along the base of the curtain wall **[Photo 2]**.

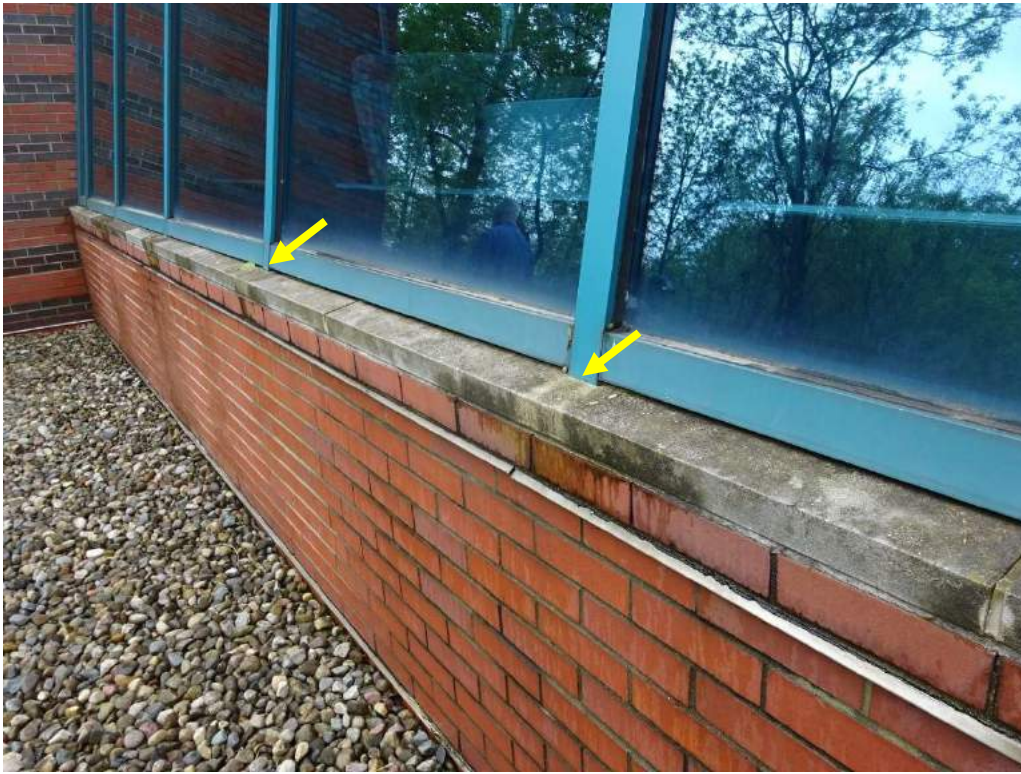
Photo 3

- The snap covers of the vertical mullions extend down and often touch the sill stone below the curtain wall **[Photo 3]**.
- Sealant has been installed in the head and bed joints of the sill stone, many of the head joints have failed adhesively.

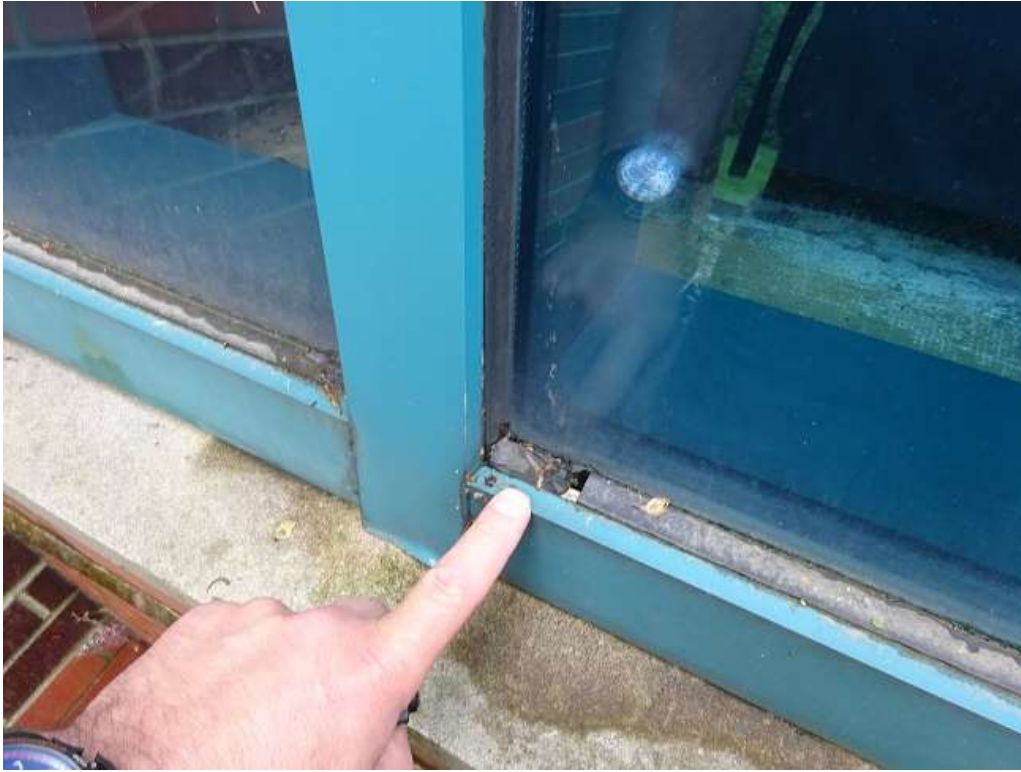
Photo 5

- Gaskets have shrunk significantly with evidence of shrinkage after they were sealed as part of a repair attempt **[Photo 5]**.
- Sealant has been installed at joints in the snap cover.

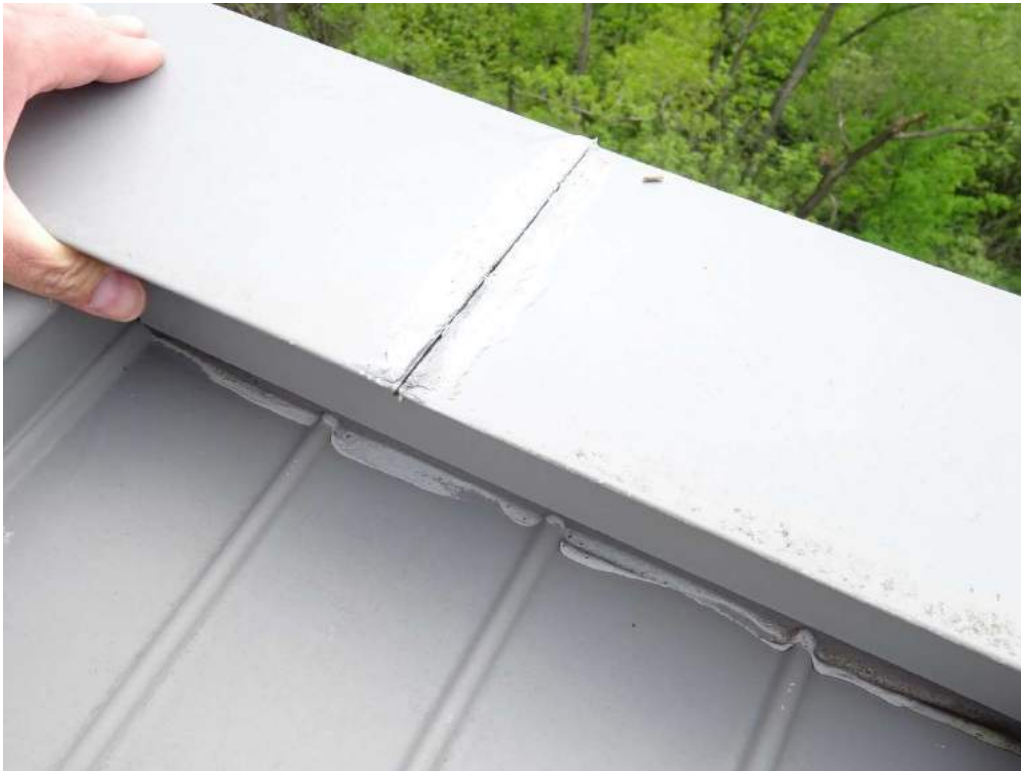
Photo 6

- Sealant on the sheet metal edge condition of the roof, located above the curtain wall, has failed **[Photo 6]**.
- Stainless steel flashing located above the roof level of the brick fins have migrated several inches out of the mortar joint **[Photo 7]**.

- Install preformed silicone tape over joints in fascia and horizontal edge metal, replace sealant joint between fascia and brick.

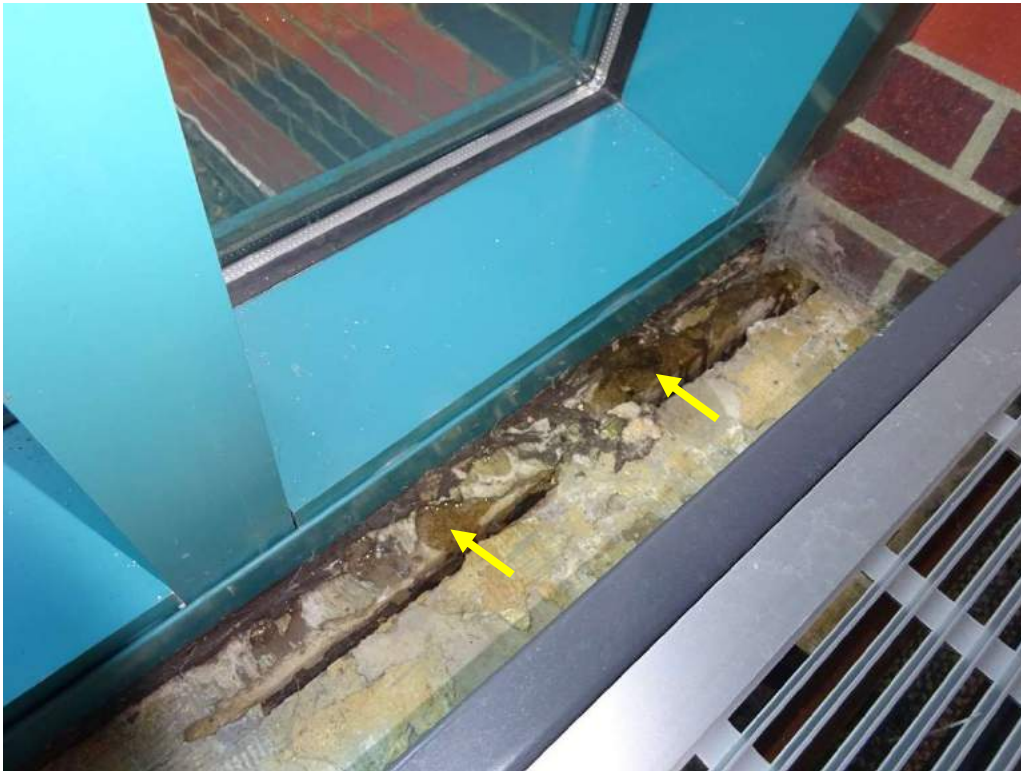
Photo 10

Water infiltration observed at the floor directly below the test specimen approximately 30 seconds into the test, **[Photo 10]**. The water infiltration continued throughout the remainder of the testing of this specimen with additional areas of infiltration observed several feet down from the test area at a joint in the prefinished trim. The water that infiltrated the system flowed into the joint between the edge of slab and the foundation wall and did not reach the carpet.

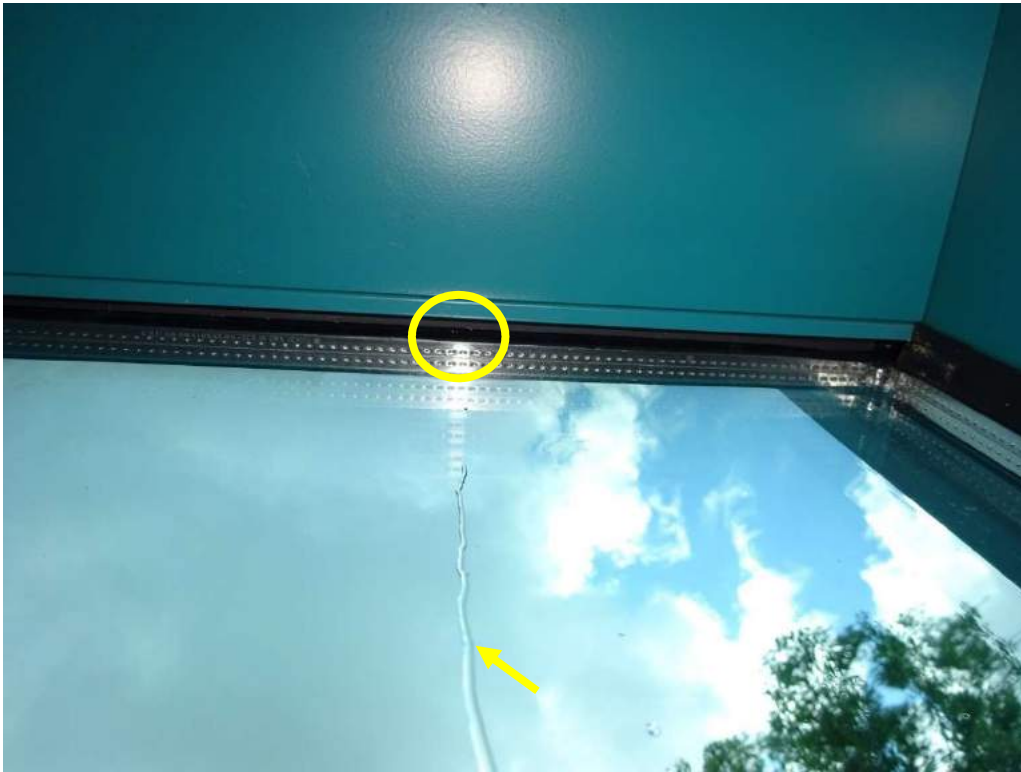
Photo 11

Water observed dripping from the horizontal mullion at the bottom of the test specimen near the end of the first section of test. Water was bypassing the spacer gasket approximately 6 inches from the vertical mullion **[Photo 11]**. This infiltration continued throughout the remainder of the testing of this Specimen.

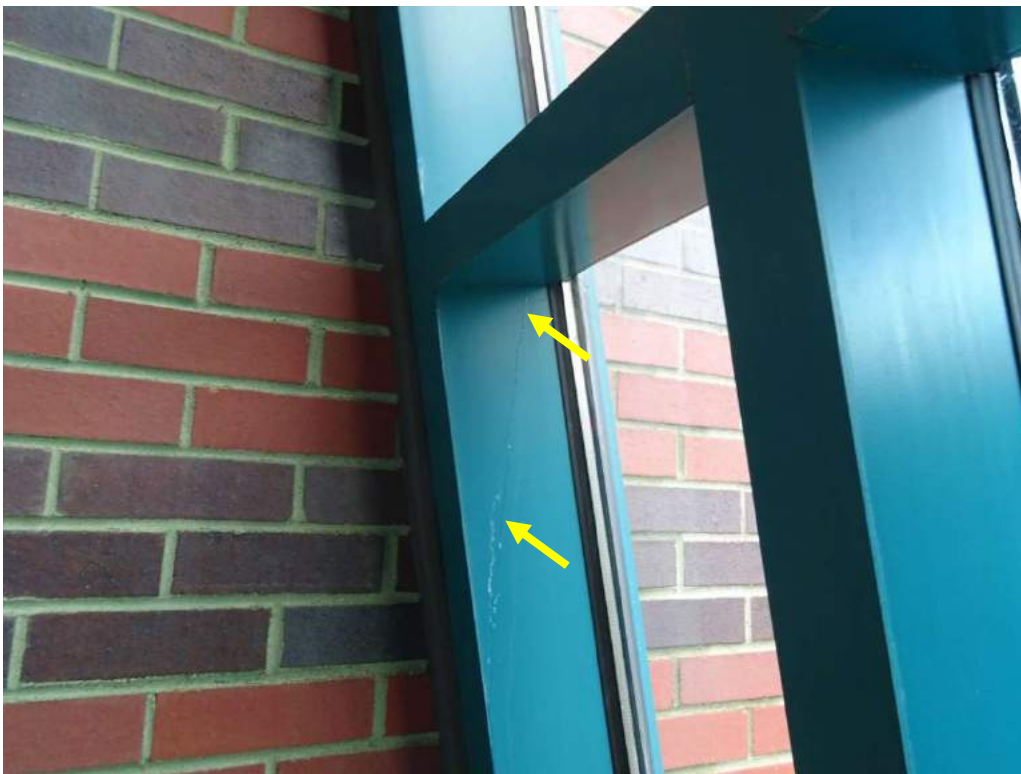
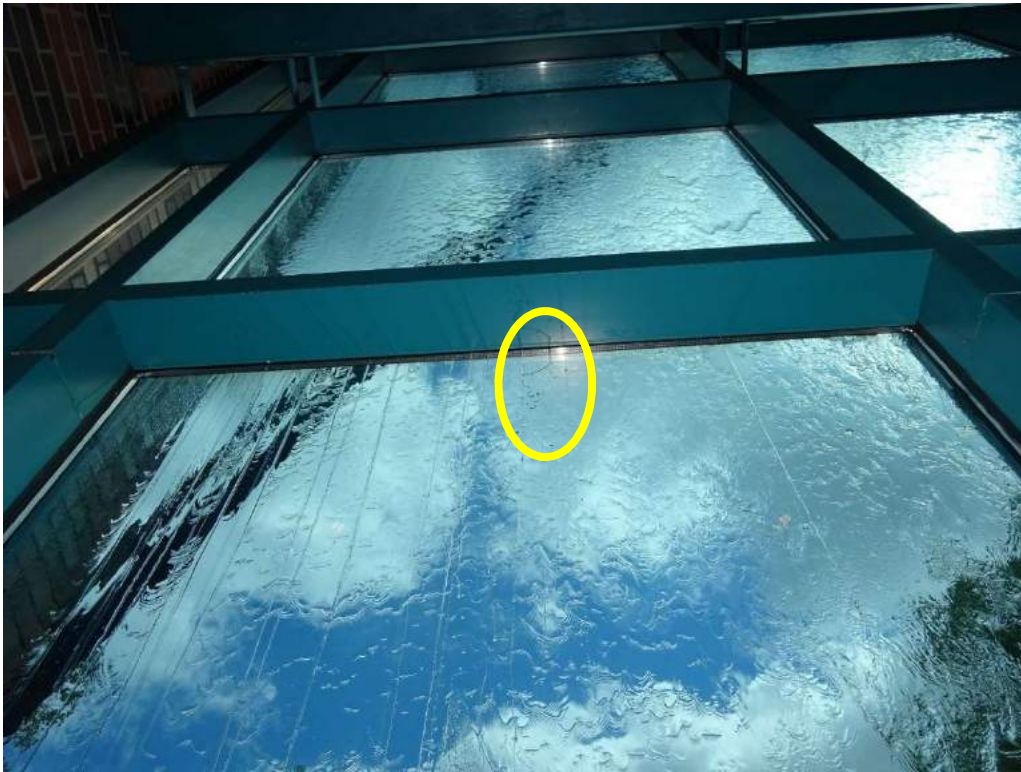
During testing of the first horizontal mullion, water was observed entering 5 glass lites below the test specimen (at the dead-load tube steel) and at the two vertical mullions located north of the test specimen **[Photo 12, 13]**. Water was observed entering at 4 different locations during the test with infiltration becoming extensive. The testing was concluded after only testing one section of horizontal and one vertical mullion due to the extent of infiltration

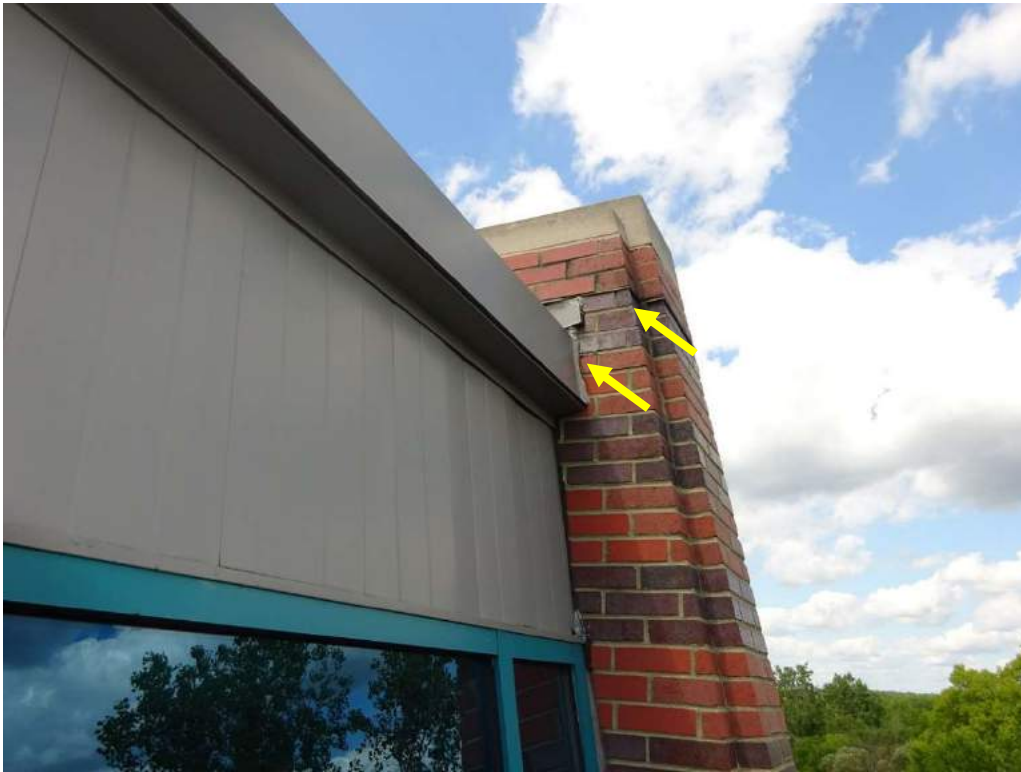
Photo 17

- The sealant joint between the metal fascia and face brick has failed adhesively **[Photo 17]**.
- The stainless steel edge of the masonry flashing located above the roof line does not extend to the east face of the fin **[Photo 17]**.

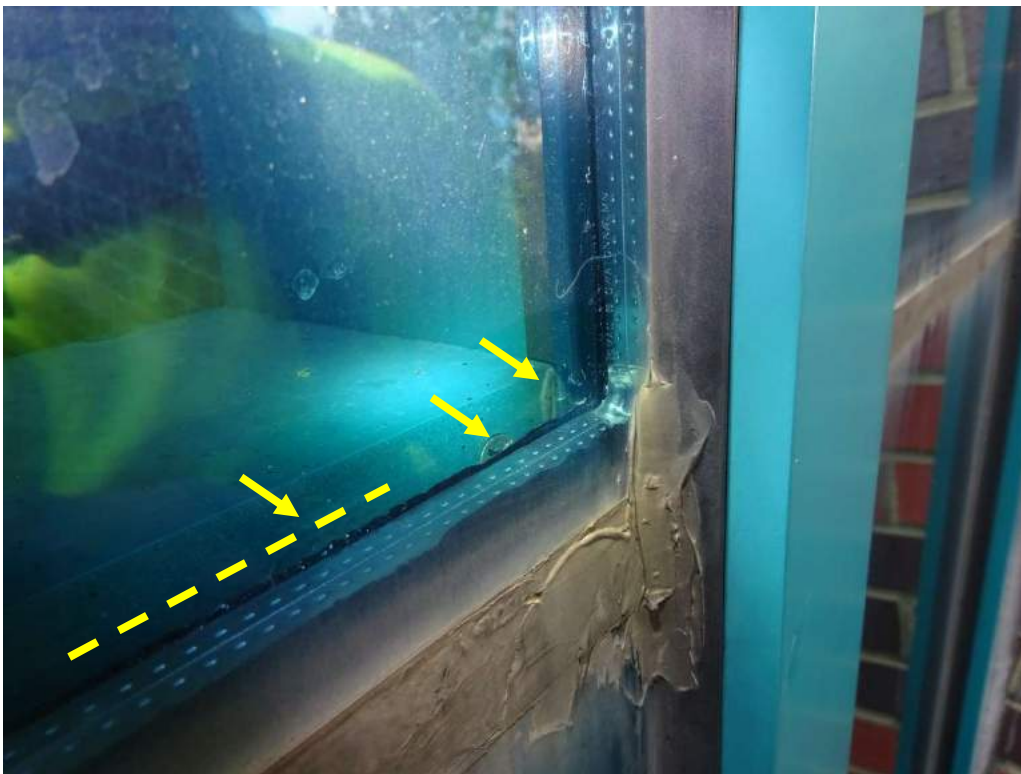
Photo 18

- Observations related to the internal seals include **[Photo 18]**:
 - The SSG seal is not installed at most of the horizontal mullions, although it was observed that the lower windows did have 3-4 inches of sealant that extended from the corner to the center of the glass on both sides.

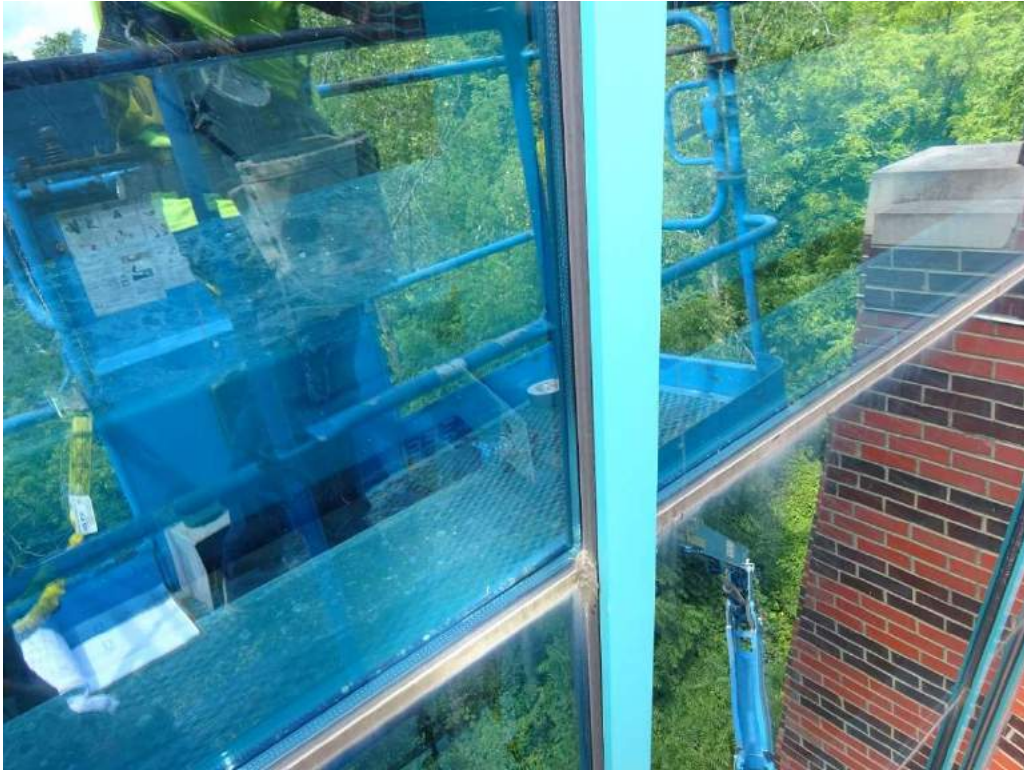
Photo 19

- Sealant at the frame joint was observed at several locations.
 - Sealant was not observed over frame screws.
- Joints between the horizontal weather seal and the gaskets of the vertical pressure bar have been sealed **[Photo 19]**.

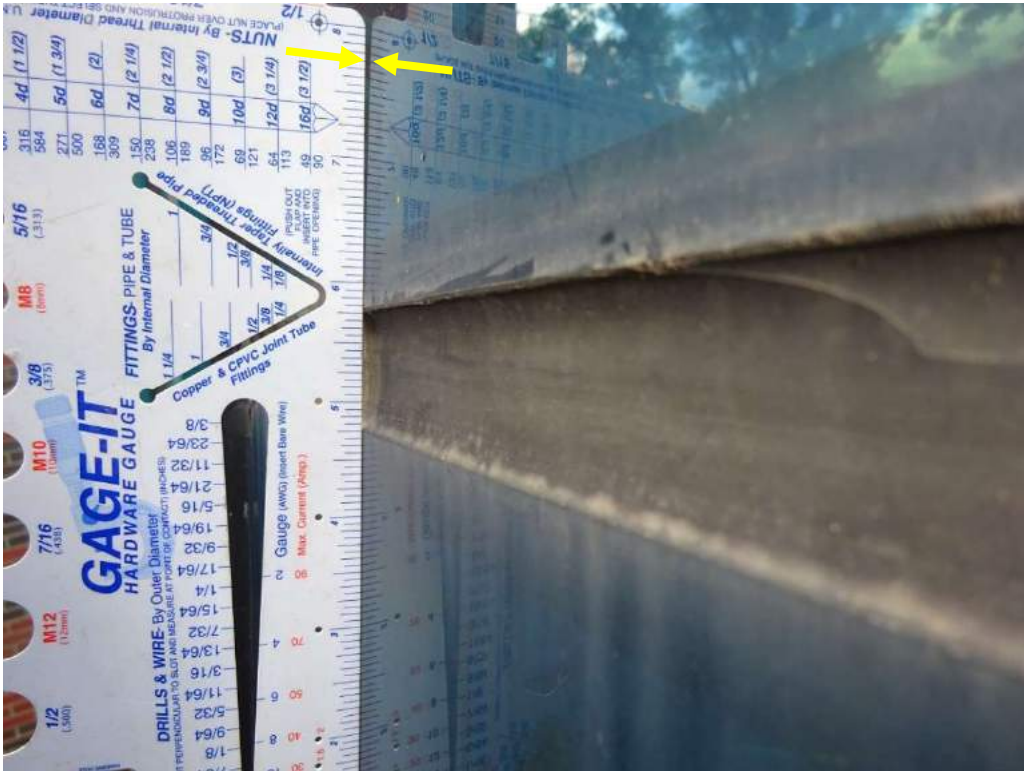
- Several pieces of glass were not aligned across the joint of the horizontal mullion **[Photo 20]**.
- Adhesion failure and “pin-holes” were noted in several locations at horizontal mullions.

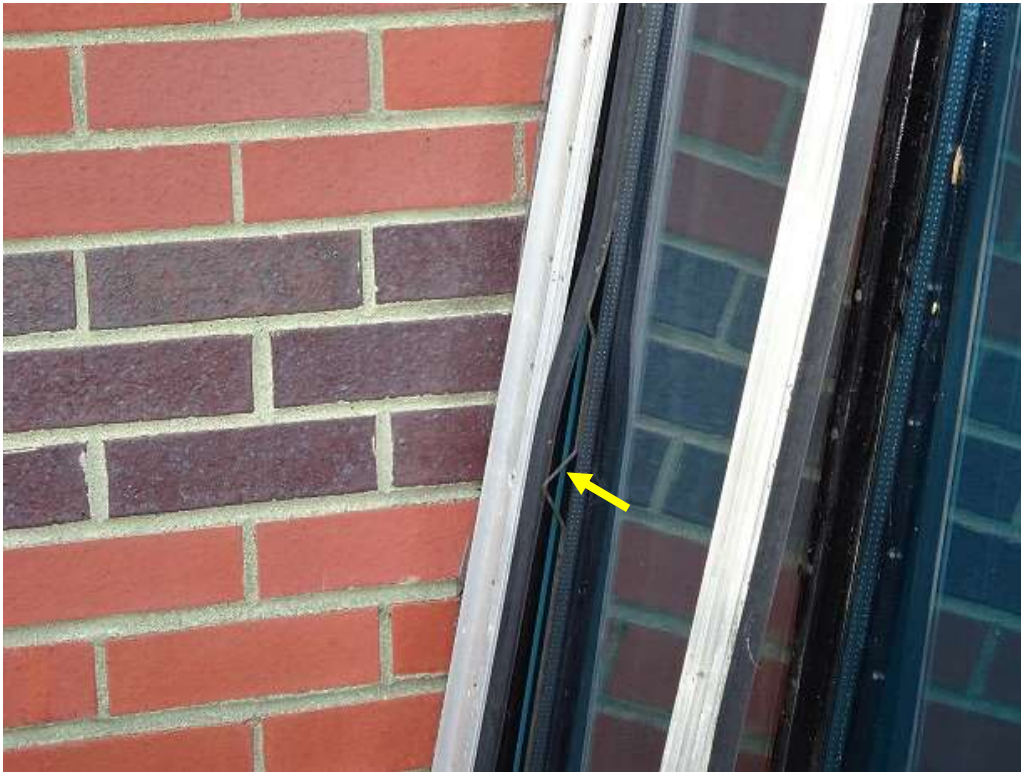
Photo 27

- Cap seals had been installed along gasket of the jamb mullion **[Photo 27]**.
- The zone dams were installed and appeared to be sealed with a non-skinning butyl product. Cracks in the sealant, consistent with shrinkage, were observed at several locations **[Photo 28]**.
- Several zone dams were removed and the sealant generally released clean from the aluminum substrate indicating that the sealant is not well bonded **[Photo 29]**.

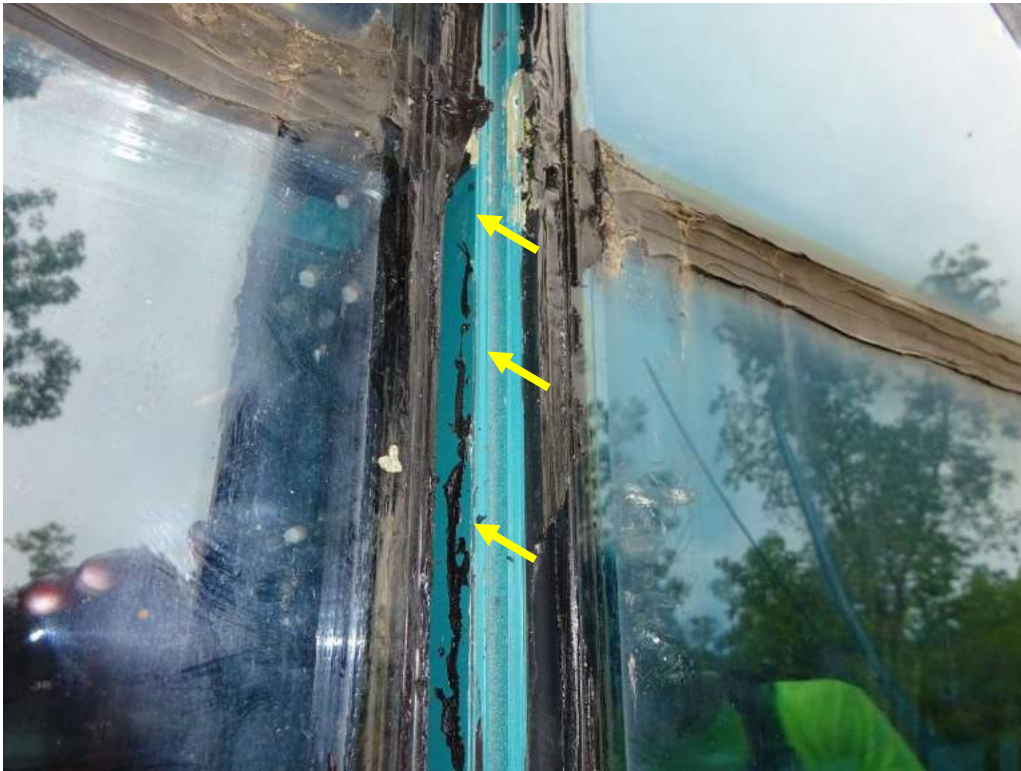
Photo 32

- Sealant displayed questionable bond when applied directly to the aluminum tongue **[Photo 32]**.
- The sealant at the frame joints is discontinuous due to sealant failure **[Photo 33]**.

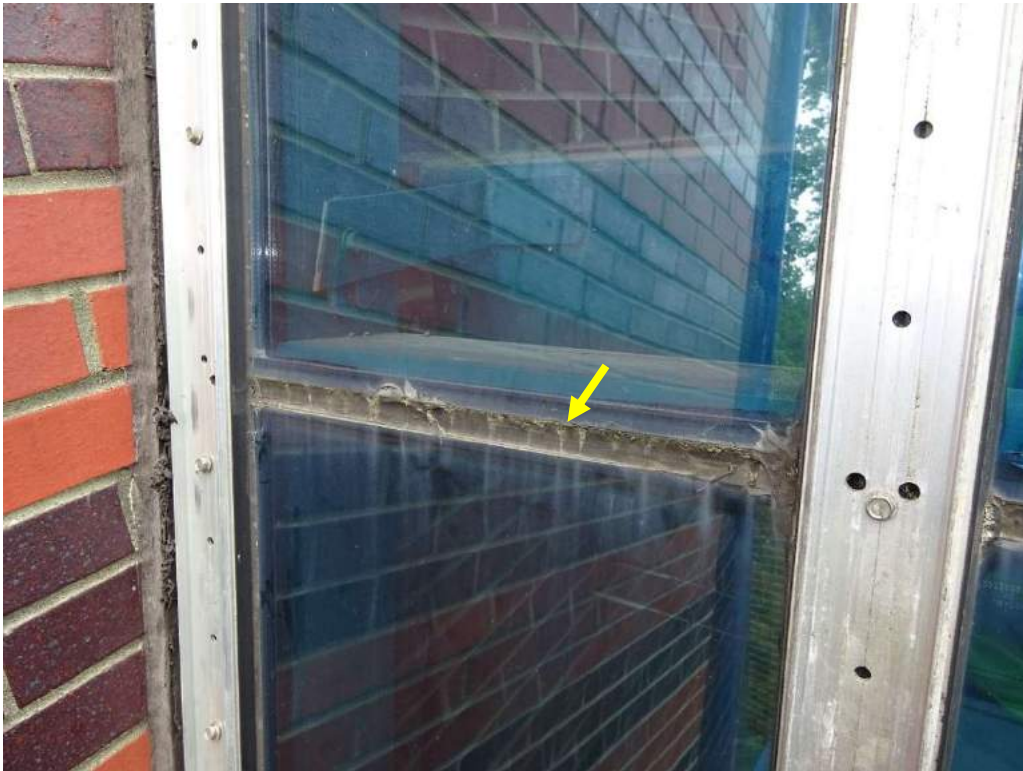
Photo 34

- Failed weather seal at horizontal joint **[Photo 34]**.
- Torque measurements of the screws used to secure the pressure bars ranged from 10 to 70 in-lbs.

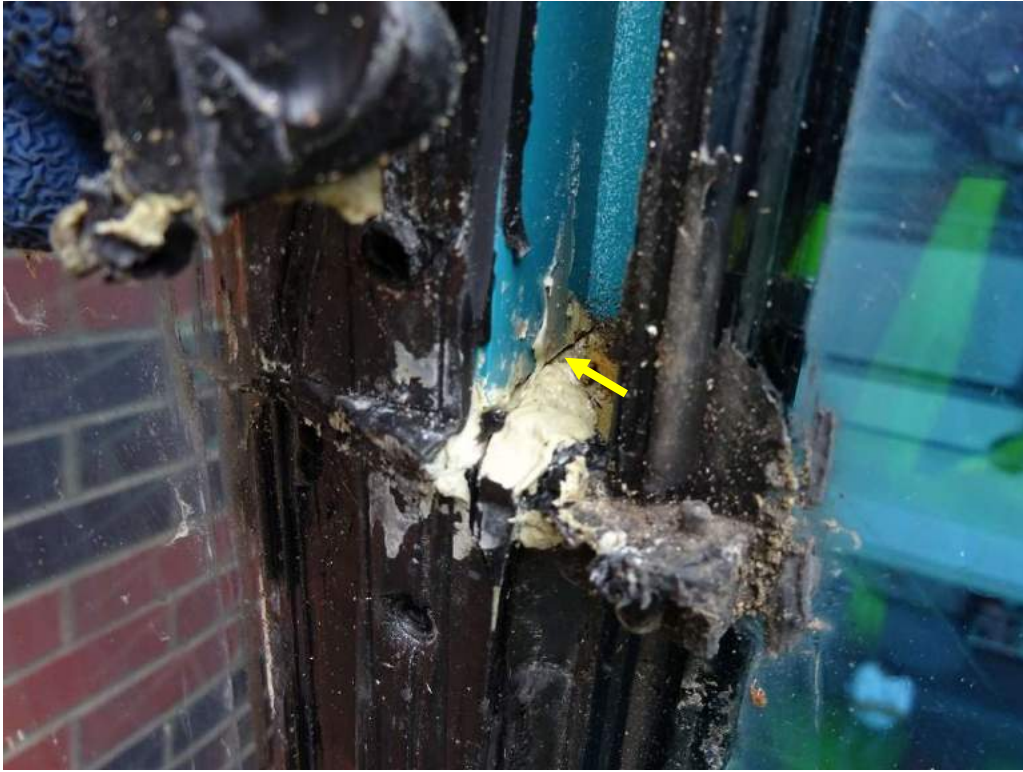
Photo 35

- The sealant at the expansion curtain wall expansion joint is discontinuous **[Photo 35]**. This condition is consistent with the use of non-curing sealant in this application.

- Water bypassing the seals at the curtain wall expansion joints due to deteriorated sealant, poor bond to the aluminum framing, and discontinuous seals at the expansion joint.

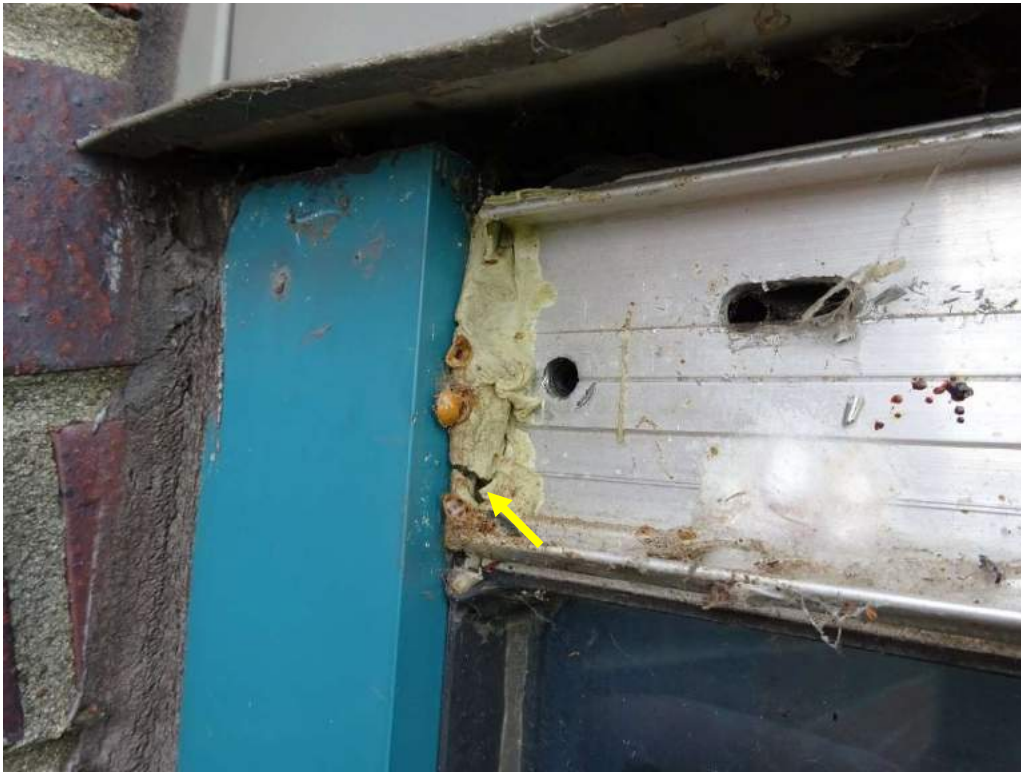
Photo 39

- Torque measurements of the 3 screws that secure the pressure bars ranged from 20 to 30 in-lbs.
- Cracking of the sealant used at the intersection of the pressure bars **[Photo 39]**.

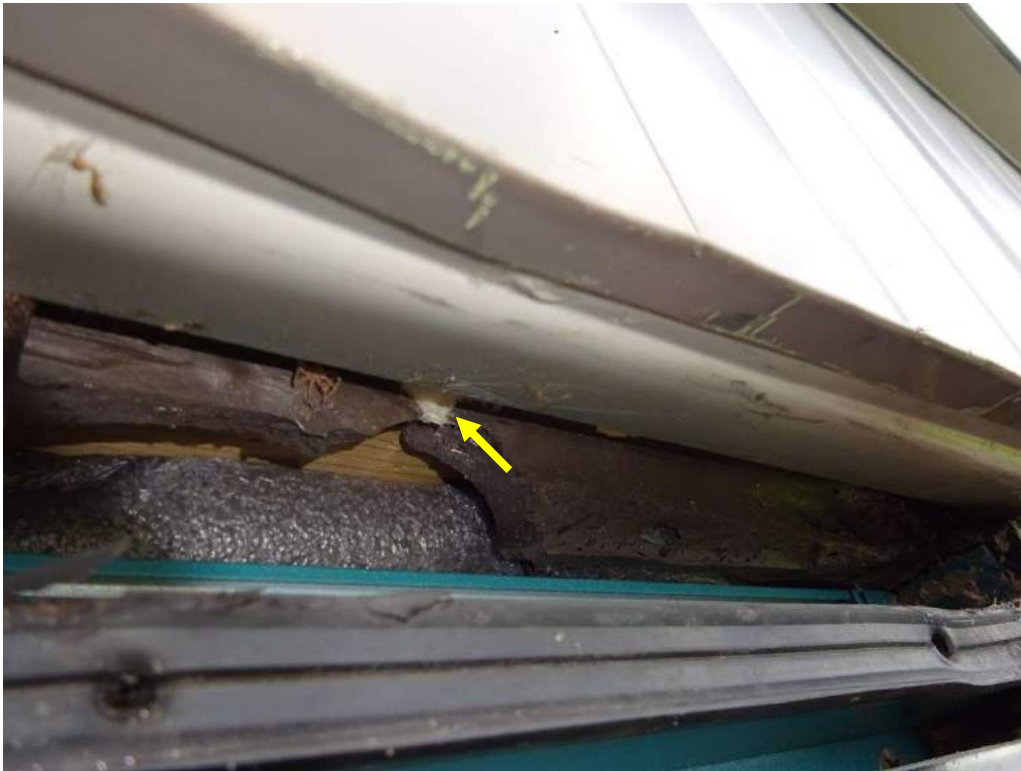
Photo 40

- The perimeter seal extended between the top of the curtain wall frame to the wood blocking and fabric weather resistive barrier (Tyvek) above. It was noted that the distance the Tyvek's returns into the opening is minimal **[Photo 40]**.
- Although an end dam was observed in the "Z" flashing it did not appear to be sealed.
- The lap in the "Z" flashing overlapped by several inches; however, sealant between the metal was not identified.

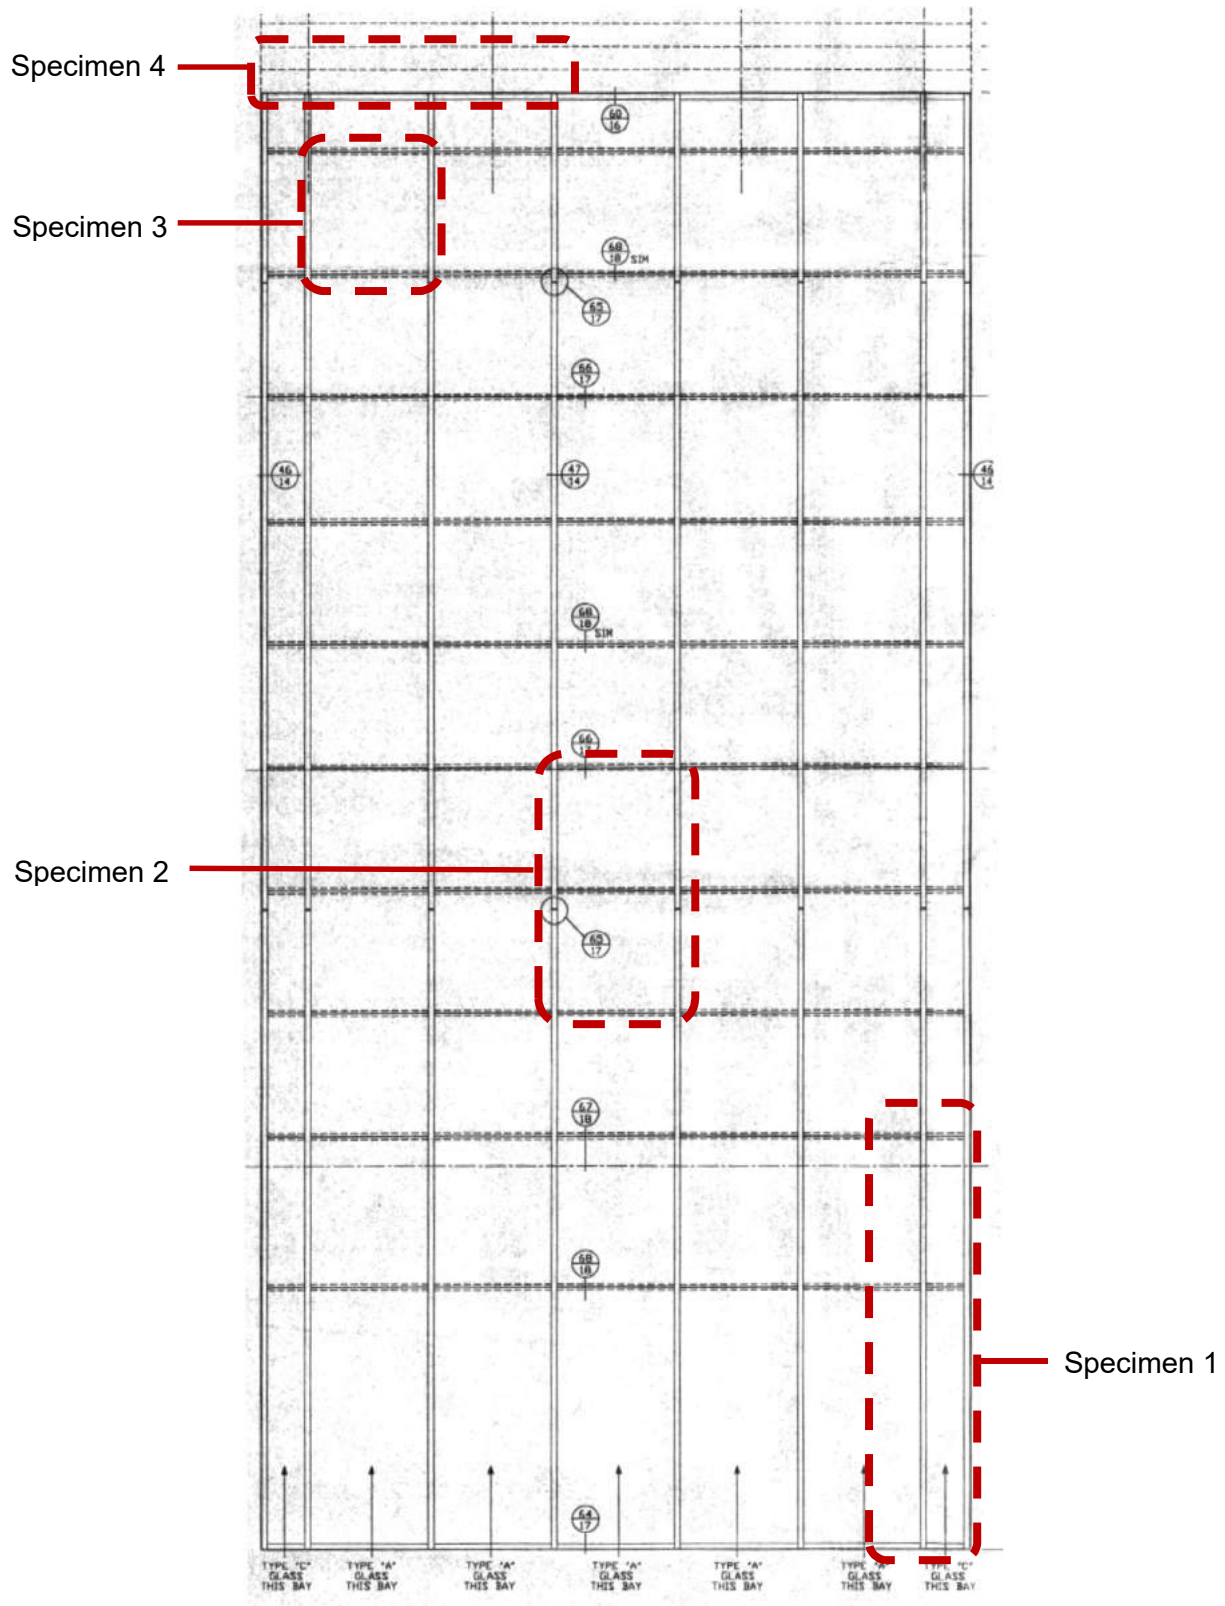
Test Locations- Interior Elevation

Testing was conducted on several portions of curtain wall CW5.1. The curtain wall was tested in three areas, a portion of the formed metal siding, located above the curtain wall, was also tested. See **Attachment B** for general locations that testing was conducted. Testing began at the bottom corner of the system at the south end and progressed up the wall. The exterior was accessed by an articulating boom manlift while the interior was observed from the floor and from a scissor lift that extended approximately half way up the wall.
