Re: Curtain wall window investigation report and recommendations

Ypsilanti District Library- Water Infiltration Investigation

Terracon Consultants, Inc. (Terracon) has completed the building enclosure consulting services proposed in Terracon's Proposal dated June 28, 2019 and authorized on August 9, 2019. This report summarizes Terracon's site activities, documents the results of our observations, and provides general recommendations for repair.

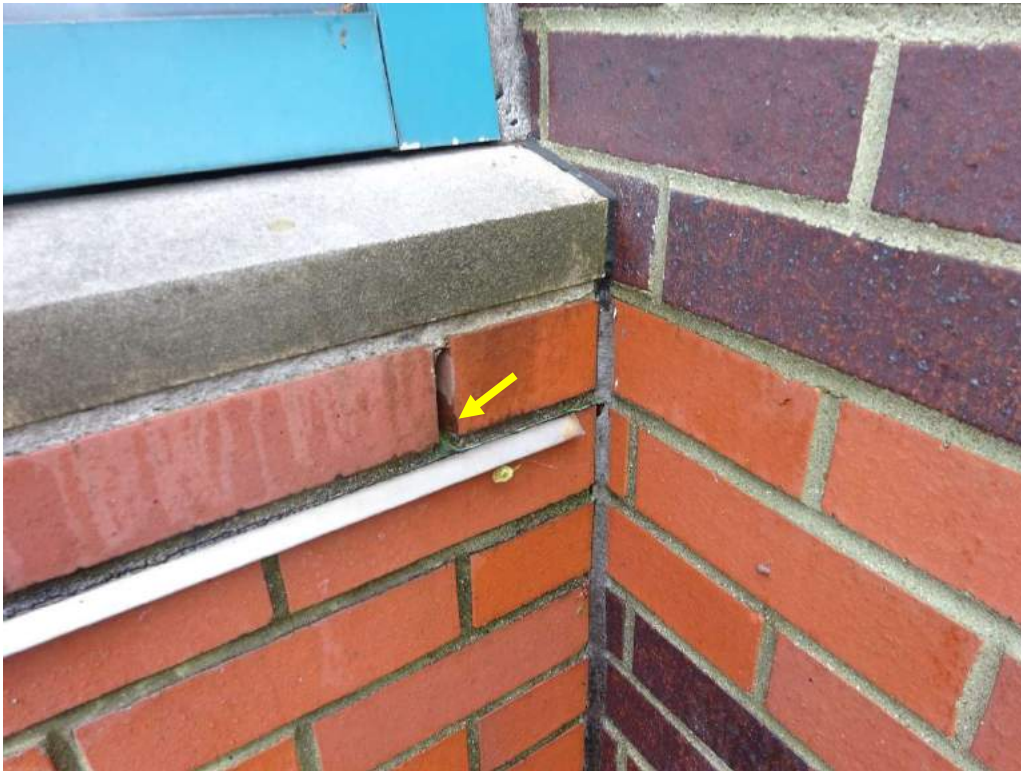
Photo 4

- The full open-head weeps are installed in the brick course located between the sill stone and the upper layer of flashing, self-adhered membrane was visible at the weep **[Photo 4]**.

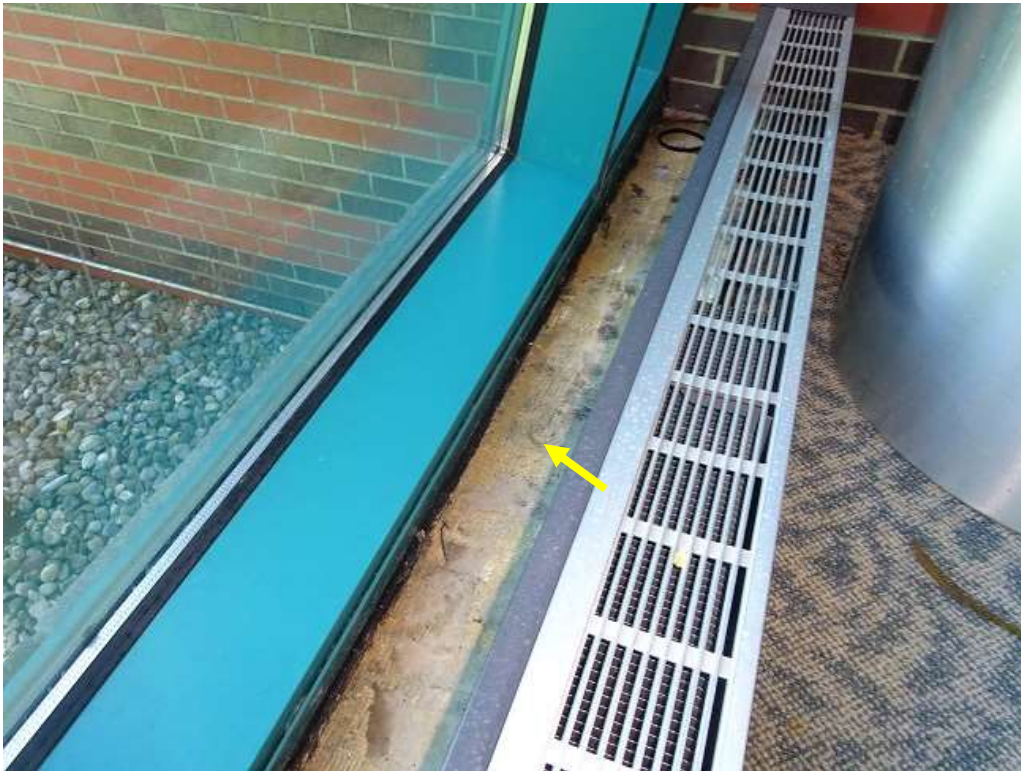
Photo 8

- The carpet has been removed from the edge of the floor slab between the radiator and the curtain wall **[Photo 8]**. The owner informed this was done to reduce the extent that water migrated toward the interior.
- A prefinished sheet metal trim has been installed along the base of the curtain wall **[Photo 9]**.

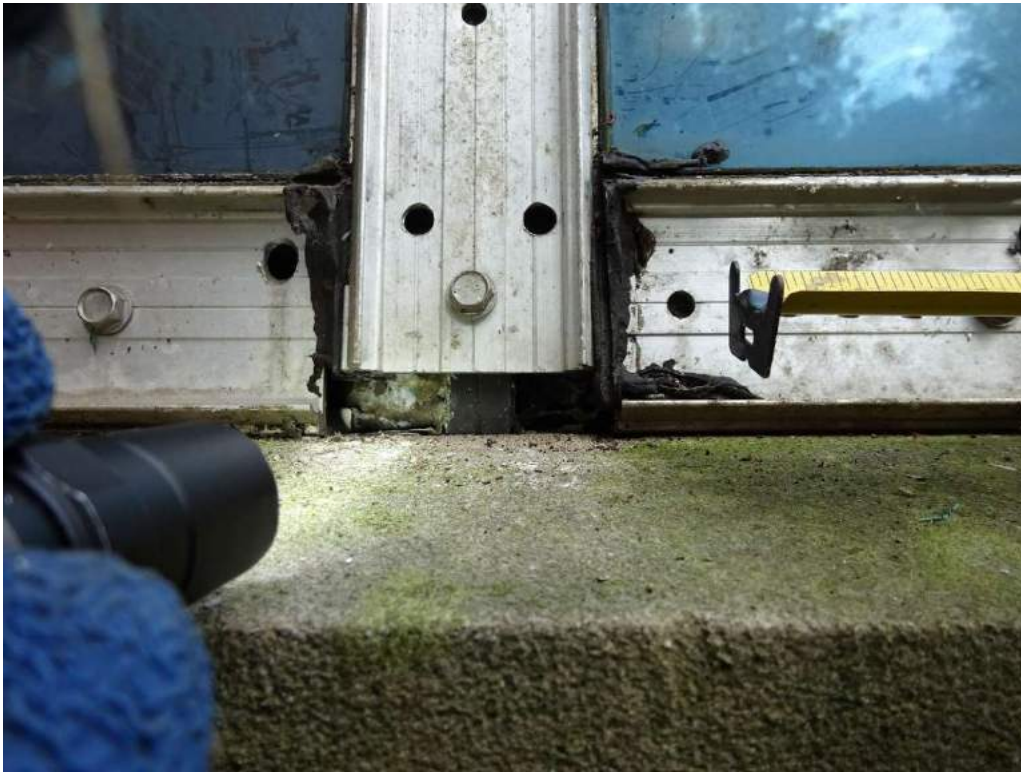
Photo 21

- Weeps had been drilled into the base of the pressure bar **[Photo 21]**.
- Sealant was installed between the edge of glass and the tongue of the vertical mullion, no sealant was installed across the joint plugs at the base **[Photo 22]**.

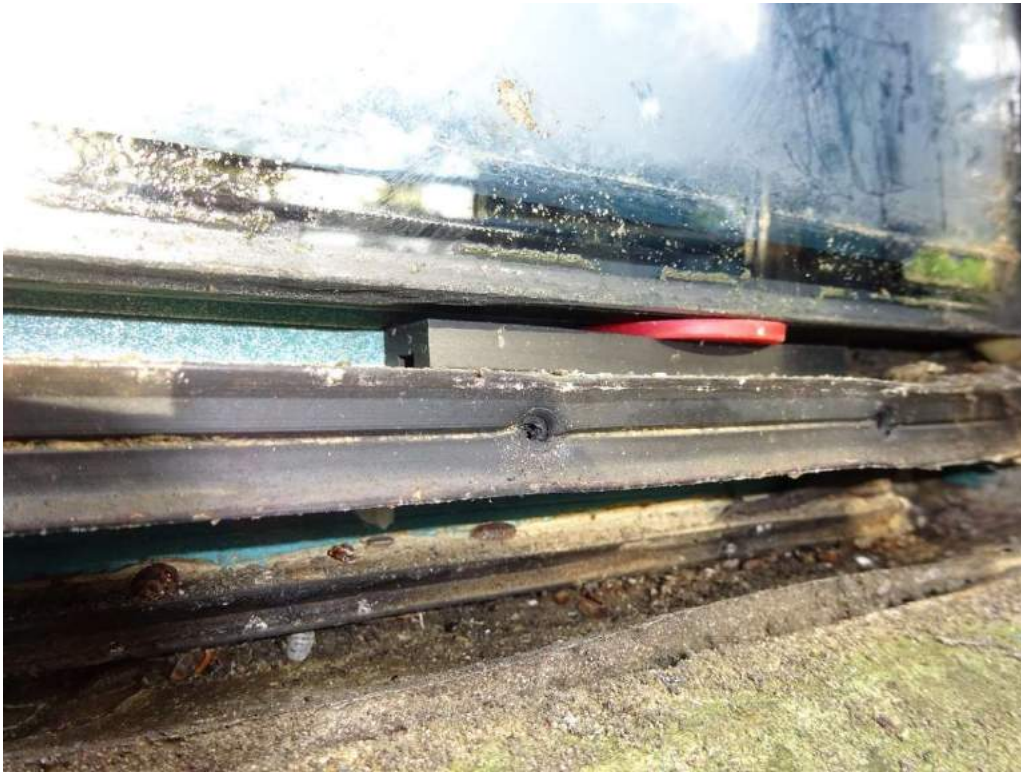
Photo 23

- The glass unit is supported with a setting block that does not support the exterior glass pane **[Photo 23]**.
- A sealant joint is installed between the bottom mullion and wood blocking below **[Photo 24]**.

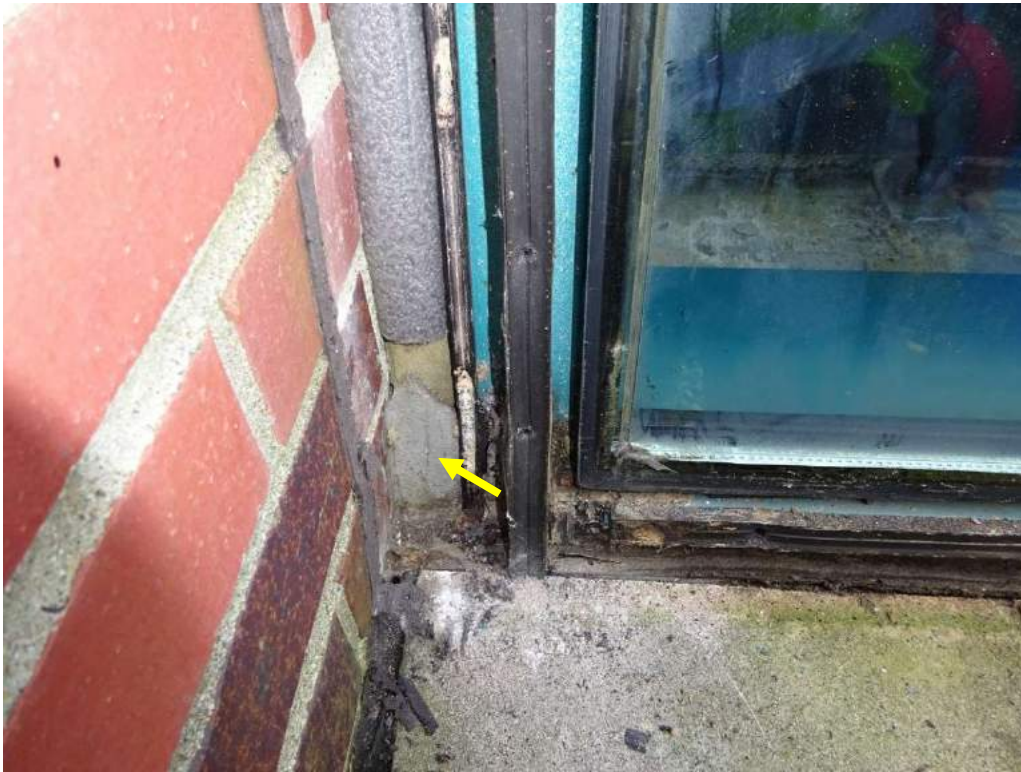
Photo 25

- The perimeter joint as the sill appears to extend up the jambs several inches behind the exposed perimeter sealant joint **[Photo 25]**.
 - The wood blocking located at the sill was wet and appeared soft in the limited area exposed.

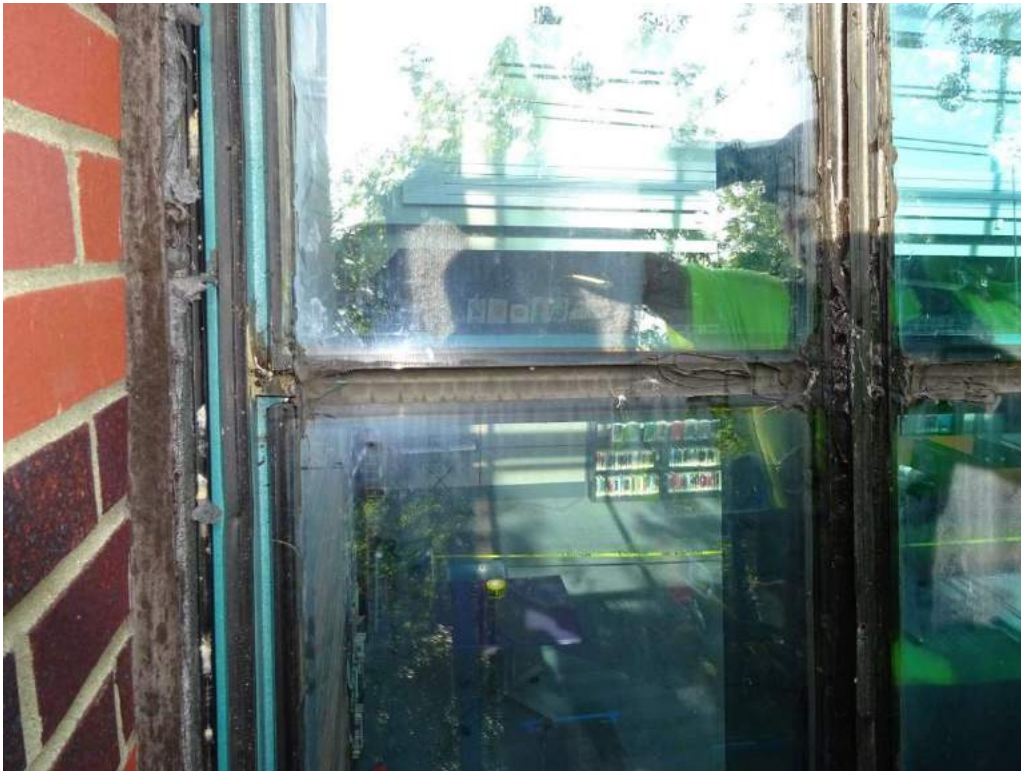
Photo 26

The portion of the pressure bars and perimeter sealant joint was removed along the south jamb near the curtain wall expansion joint **[Photo 26]**.

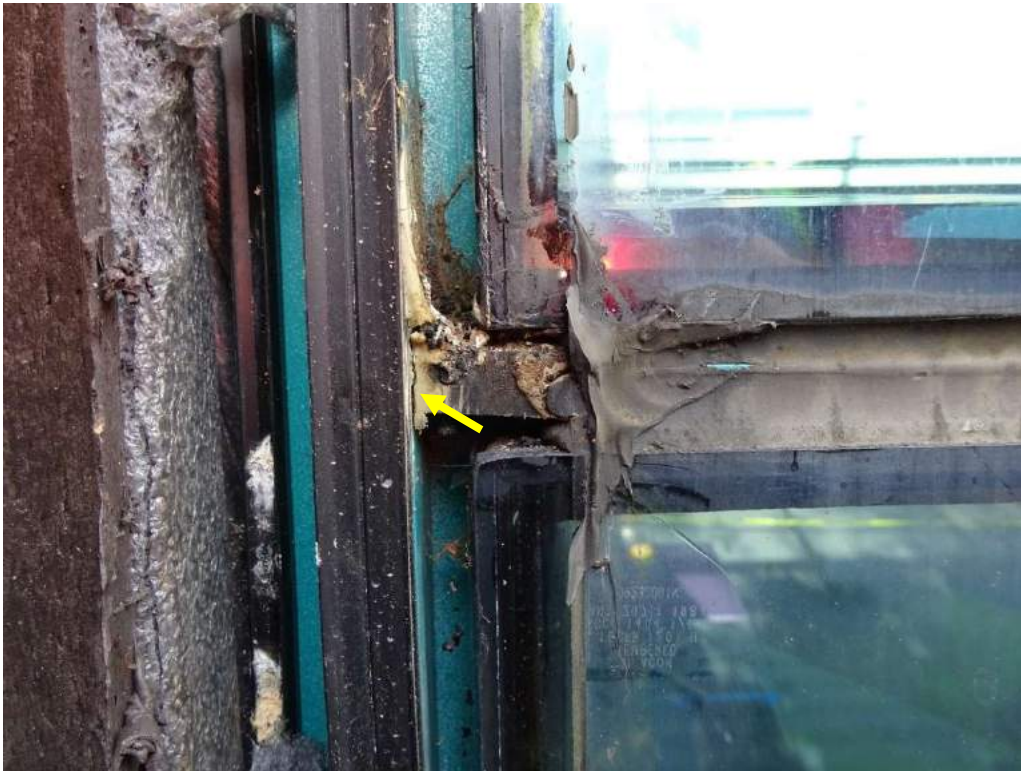
Photo 28

- Cap seals had been installed along gasket of the jamb mullion **[Photo 27]**.
- The zone dams were installed and appeared to be sealed with a non-skinning butyl product. Cracks in the sealant, consistent with shrinkage, were observed at several locations **[Photo 28]**.
- Several zone dams were removed and the sealant generally released clean from the aluminum substrate indicating that the sealant is not well bonded **[Photo 29]**.
